Evaluation Of Thermal Sprayed Metallic Coatings For Use On The Structures At Launch Complex 39

Peter J. Welch
Engineering Development Directorate
Ground Support Office
Materials Analysis Office
Materials Testing Branch

MTB-1058-89

SUBJECT: EVALUATION OF THERMAL SPRAYED METALLIC COATINGS FOR USE
ON THE STRUCTURES AT LAUNCH COMPLEX 39

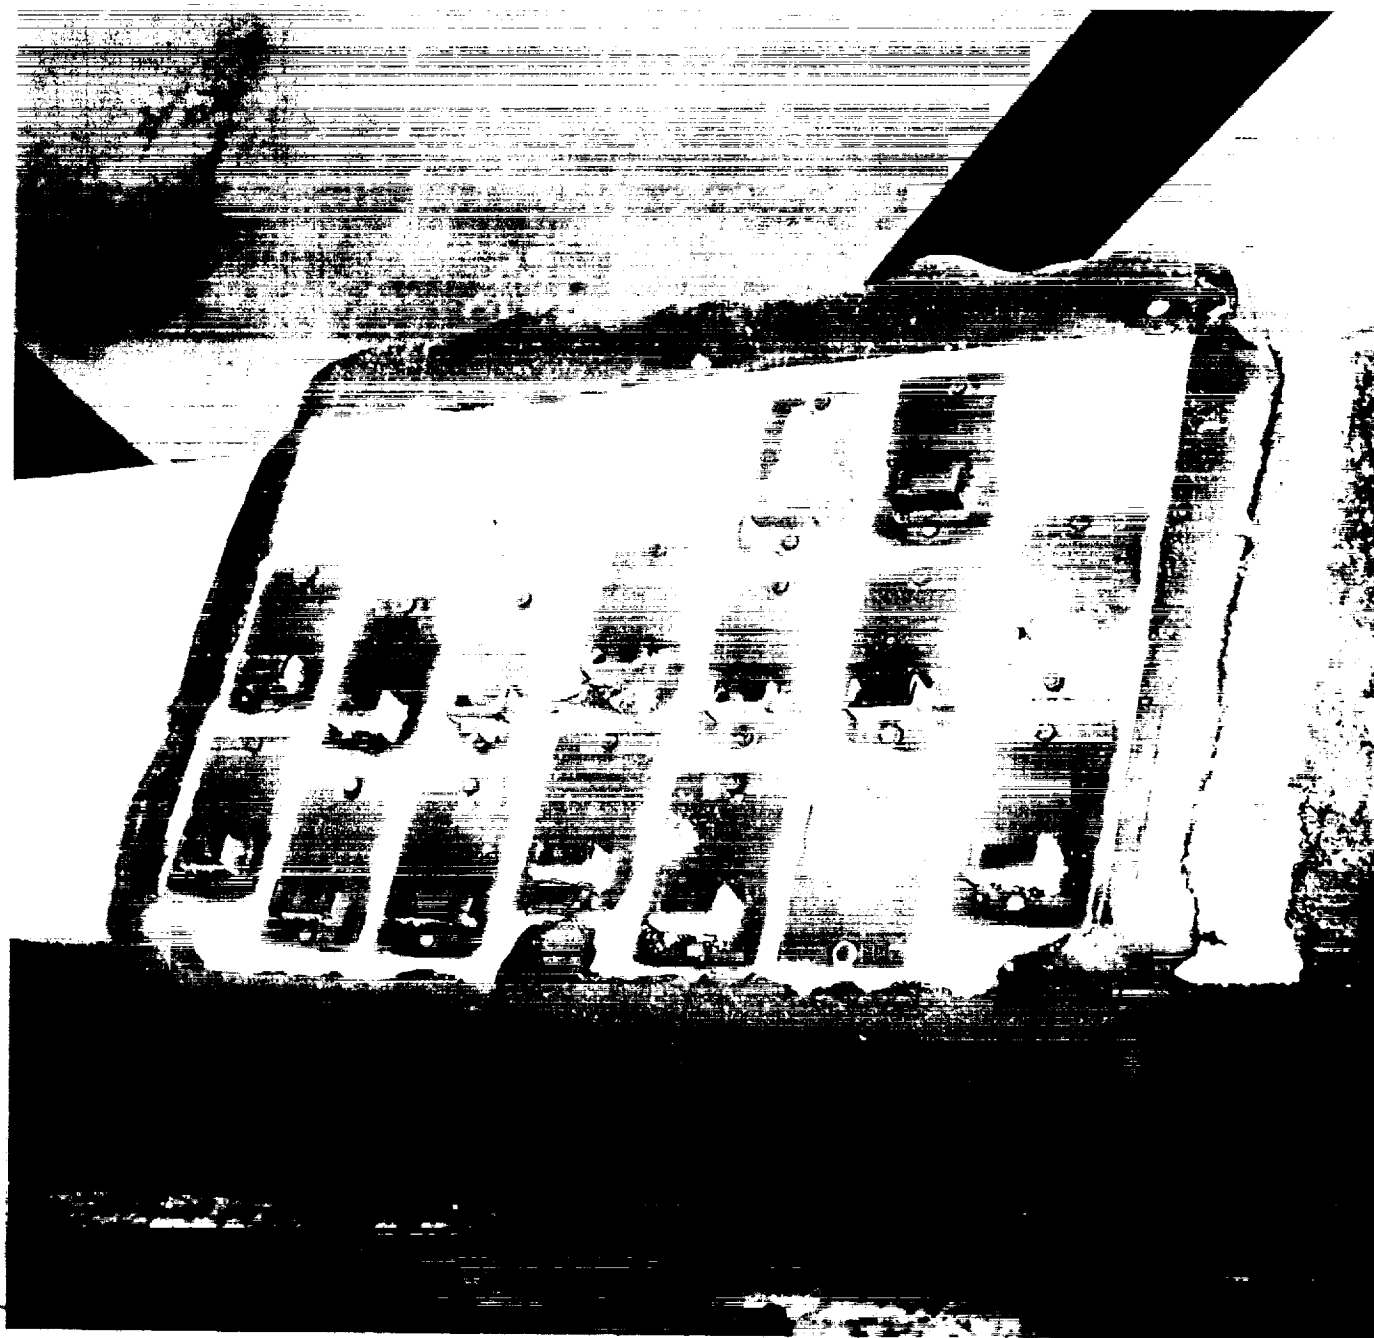
FIGURE 2

THE MOUNT PLATE WITH TSC COMPOSITE TEST PANELS IS SHOWN MOUNTED ON THE TITAN TRANSPORTER AFTER THE TITAN LAUNCH ON SEPTEMBER 5, 1989.

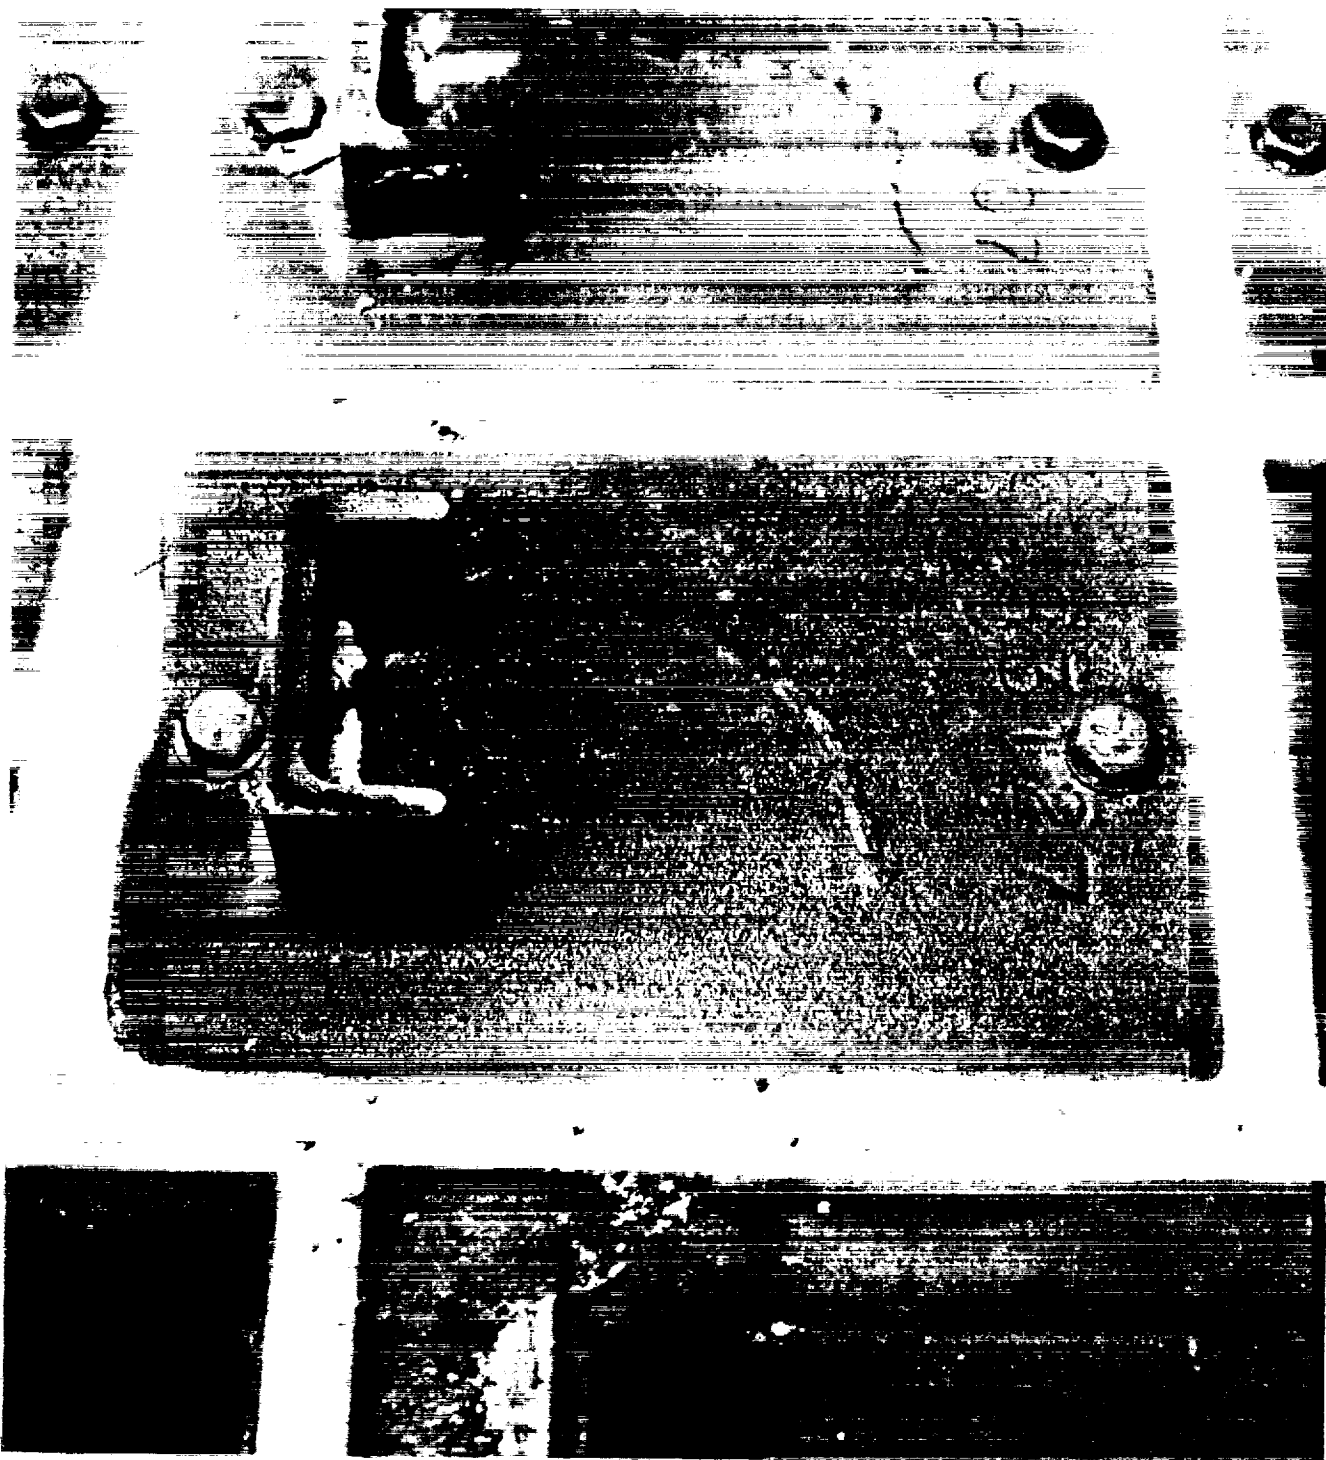
FIGURE 3

THE ALUMINUM TSC TEST PANEL, S/N 83127, WAS THE ONLY TSC PANEL WHICH DID NOT APPEAR TO SUSTAIN ANY DAMAGE FROM THE TITAN LAUNCH ENVIRONMENT.

3.3 Of the eleven new TSC panels only S/N 83127 showed no noticeable damage (see Figure 3). It was coated with aluminum. The results of all the panels are presented in Table II.

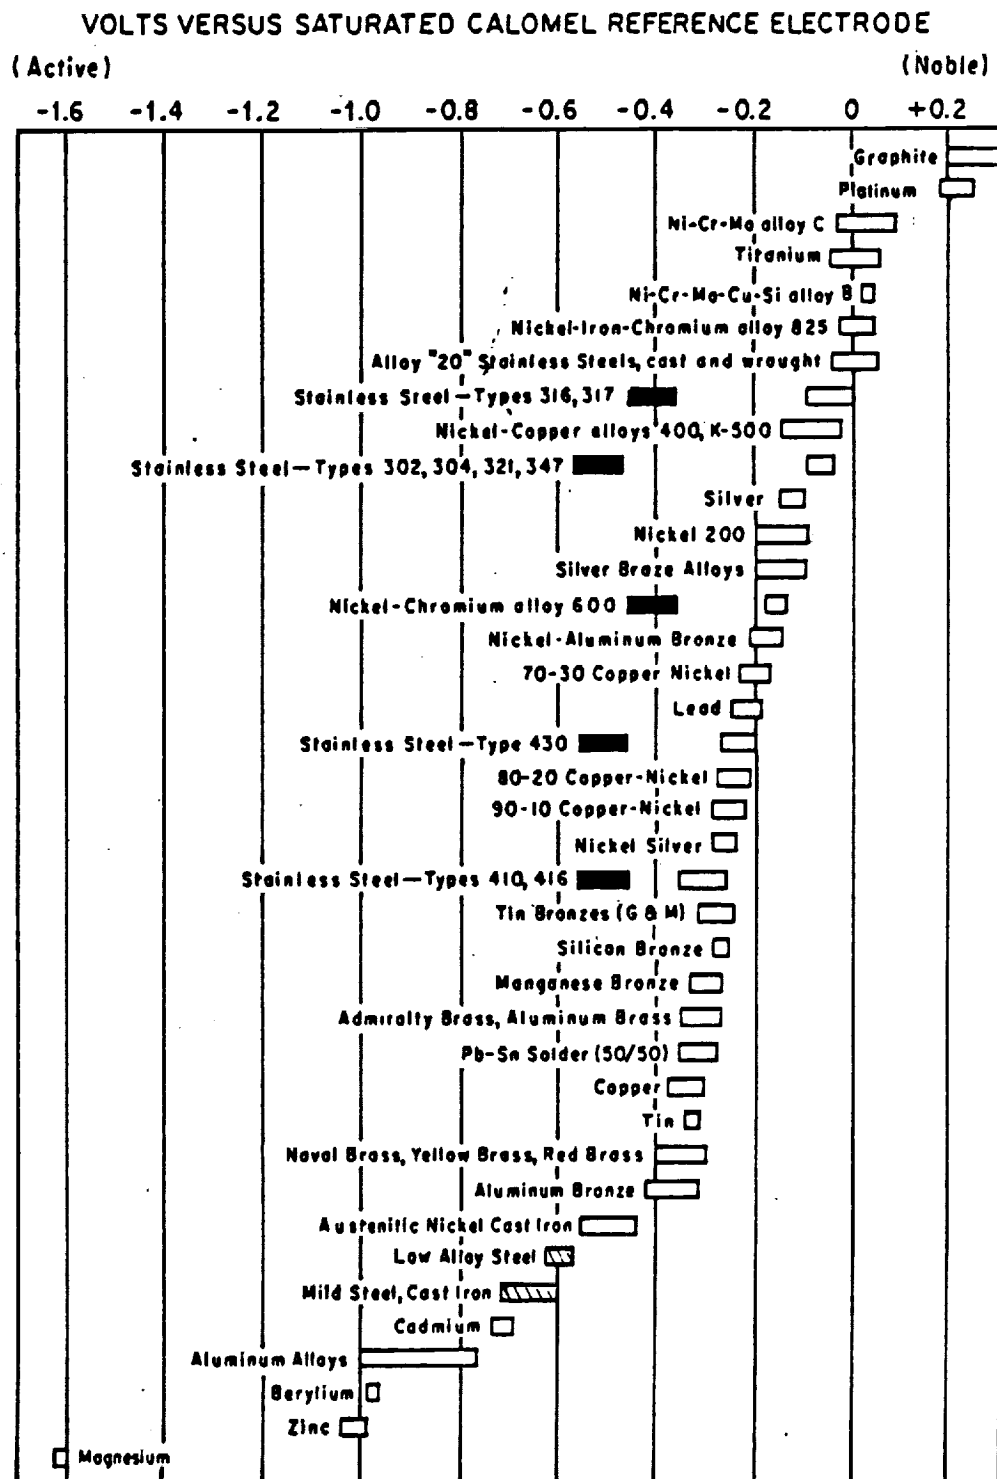
FIGURE 5

NOTE—Dark boxes indicate active behavior of active-passive alloys.

GALVANIC SERIES OF VARIOUS METALS IN FLOWING SEAWATER
(REFERENCE ASTM G 82-83).

4.1 Inorganic zinc paint is the standard protective coating for steel structures at Kennedy Space Center (KSC). In some applications inorganic zinc is utilized with epoxy and urethane based top coats. The zinc paint provides cathodic protection for the steel. As shown in the galvanic series (see Figure 5) zinc is more active than mild steel and low alloy steel; therefore, as a coating it corrodes sacrificially and provides a protective oxide barrier over the steel structure.
